MR Imaging of Acl Injuries and Associated Complications

Type of Publication: Original Research Article

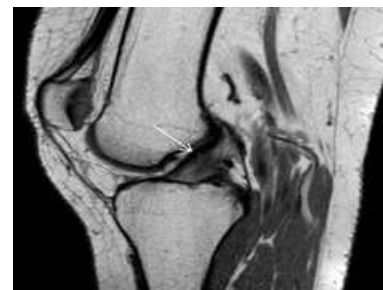
Figure 6: Blumensaat line

Expected course can be evaluated by comparing the trajectory of ACL with that of Blumensaat line. The Blumensaat line is the line drawn along the roof of the intercondylar notch (posterior surface) of the femur as seen on lateral radiograph of the knee joint (Figure 6).

When ACL has a normal trajectory, it forms together with the Blumensaat line an arrow which points backwards (or upwards) When ACL has an abnormal trajectory, then it forms together with the Blumensaat line an arrow which points forwards (or downwards).

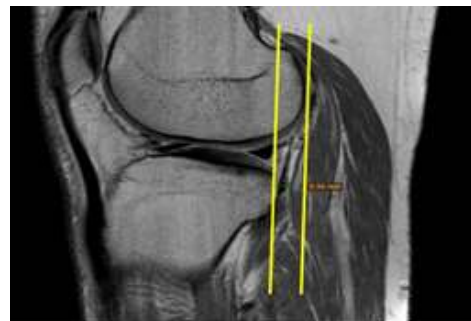
Figure 13: Sagittal T1W image demonstrates anterior tibial translation of more than 5mm in a patient with ACL lesion.

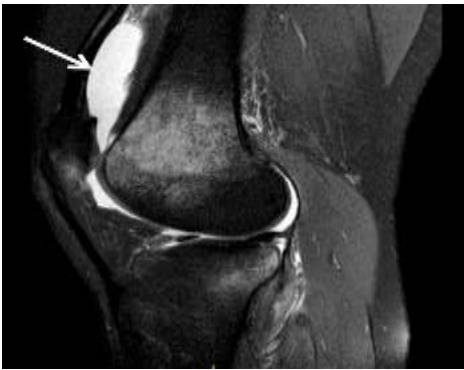
Figure 14: Sagittal PDFS image demonstrates bone edema and joint effusion joint effusion

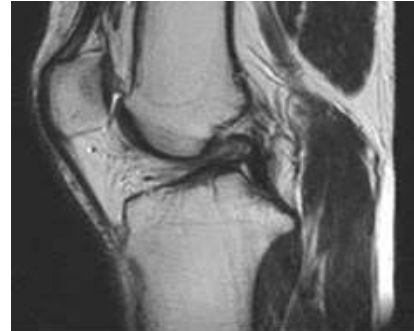
Figure 15: Sagittal PDFS image demonstrate fragmentation of ACL which is horizontally oriented and scarred on PCL.

Chronic tear

- In chronic tears of the ACL, there is no edema and synovitis nor there irregularity of the free concave edge of Hoffa's fat pad.
- There can be small chronic joint effusion.
- The ACL may not be visualized on sagittal or coronal images.
- Absence of ACL in the lateral intercondylar notch on coronal MR images is termed as empty notch sign (empty lateral wall).

- The ACL may also appear attenuated or small in chronic tears.
- The chronically teared ACL can be scarred to the surrounding adjacent structures.
