Pattern of Bone Marrow Edema in Traumatic Knee and Its Association with Ligamentous Knee Injuries on Magnetic Resonance Imaging

Type of Publication: Original Research Article

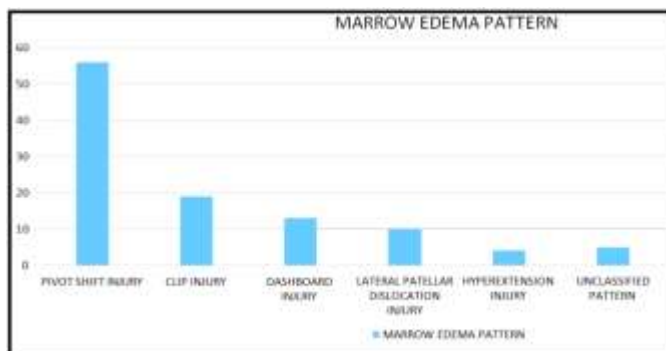
Graph 1:

Five patterns of marrow edema were observed:

Marrow Edema Pattern	Cases And Percentage	Most Common Ligamentous Injury
Pivot Shift Injury	56 (51.3%)	Acl Sprain Or Tear {48 Of 56 Cases (85.17%)}
Clip Injury	19 (17.4%)	MCL Sprain Or Tear {15 Of 19 Cases (78.9%)}
Dashboard Injury	13 (11.3%)	PCL Sprain Or Tear {10 Of 13 Cases (76.9%)}
Lateral Patellar Dislocation Injury	10 (9.1%)	MPLR Sprain Or Tear {9 Of 10 Cases (90%)}
Hyperextension Injury	4 (3.6%)	Acl Sprain Or Tear {2 Of 4 Cases (50%)}
Unclassified Pattern	5 (5.5%)

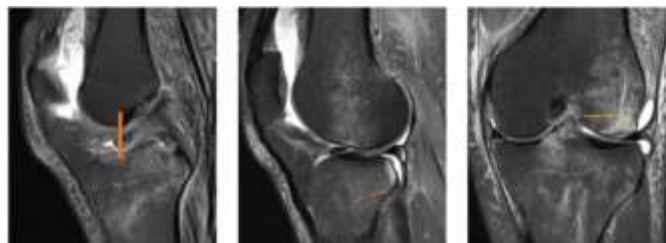
Figure 1: Pivot Shift Injury

Bone marrow edema in the postero-lateral aspect of tibia (arrow in middle image) and the lateral femoral condyle (arrow in right lateral image) with avulsion fracture of the anterior cruciate ligament (arrow in left lateral image).

- Pivot shift injury results from application of valgus load to the knee in various degree of flexion combined with external rotation of the tibia or internal rotation of the femur with resultant avulsion of Anterior Cruciate Ligament (ACL).
- Clip injury occurs after a pure valgus stress is applied to the knee while the knee is in a state of mild flexion.
- Dashboard injury occurs when force is applied to the anterior aspect of the proximal tibia while the knee is in a flexed position.
- Hyperextension injury of the knee results when direct force is applied to the anterior tibia while the foot is planted or from an indirect force, such as a forceful kicking.
- Patellar dislocation injury occurs when femur rotates internally on a fixed tibia on the flexed knee, contraction of the quadriceps occurs, leading to lateral dislocation of the patella out of the trochlear groove

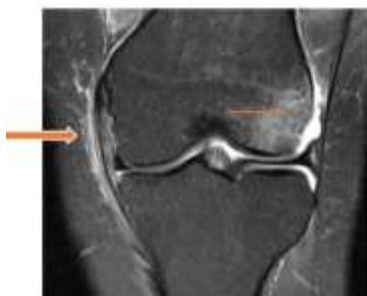
Figure 2: CLIP Injury

Marrow edema (thin arrow) seen at the lateral femoral condyle with sprain of the medial collateral ligament (thick arrow).

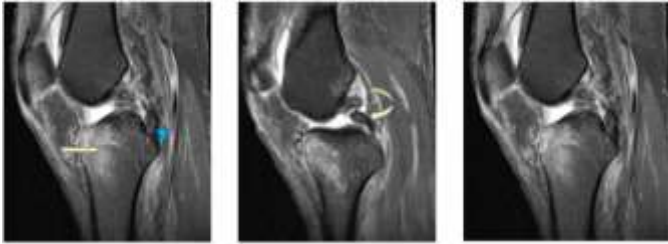
Figure 3: Dashboard Injury

Sequential PDFS Sag images showing complete mid-substance tear of the PCL (asterisk) with medially flipped medial meniscus body (curved arrow) and marrow edema of the anterior tibia (arrow).

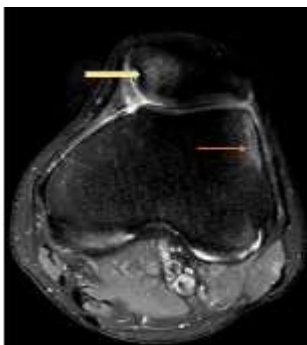
Figure 4: Lateral Patellar Dislocation Injury

Marrow edema seen along the lateral femoral condyle (thin arrow) and the medial facet of patella (thick arrow) s/o patellar dislocation-relocation injury.

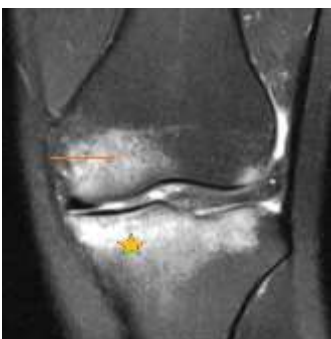
Figure 5: Hyperextension Injury

Marrow edema seen involving the medial femoral condyle (thin arrow) and the tibial plateau (thick arrow)

suggestive of kissing contusions in hyperextension injury.
